About Chulitna River Bridge

The Chulitna River Bridge, located in Anchorage, Alaska, was originally built in 1970 and was widened in 1993. This five-girder, five-span bridge crosses one of the longest straight sections of the Chulitna River and has become a popular route for heavy, overload vehicles (over 410,000lbs), as it is the most direct route connecting Anchorage, to Fairbanks and Prudhoe Bay.

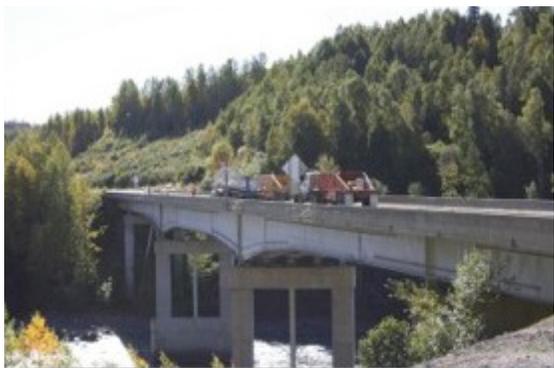
Luna's os3155 rugged fiber optic strain gages are installed along exterior steel plate girders to measure strains for loads that can run as high as 410,000 lbs.

Luna's solution divided the bridge into three monitoring zones based on the number of sensors in each zone. Luna's os3155 rugged fiber optic strain gages were installed long exterior steel plate girders to measure strain for loads that can run as high as 410,000lbs. This type of installation allows for a fast, simple, and repeatable process. Luna displacement gages were mounted on the rocker bearings to monitor movement away from the supports, as the bridge expands and contracts in response to the large temperature swings of up to 70°C. Cameras were also installed in multiple locations under the bridge, providing a means for visual inspection of the rock bearings and an added measure of security.

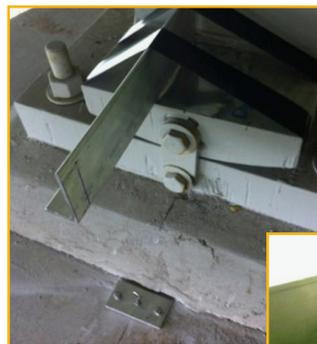
Displacement gages are mounted on the rocker bearings to monitor movement away from the supports as the bridge expands and contracts in response to changes of up to 70°C
