Micron Optics, Inc.

os4400 Series Temperature Sensing Cable

Test Summary

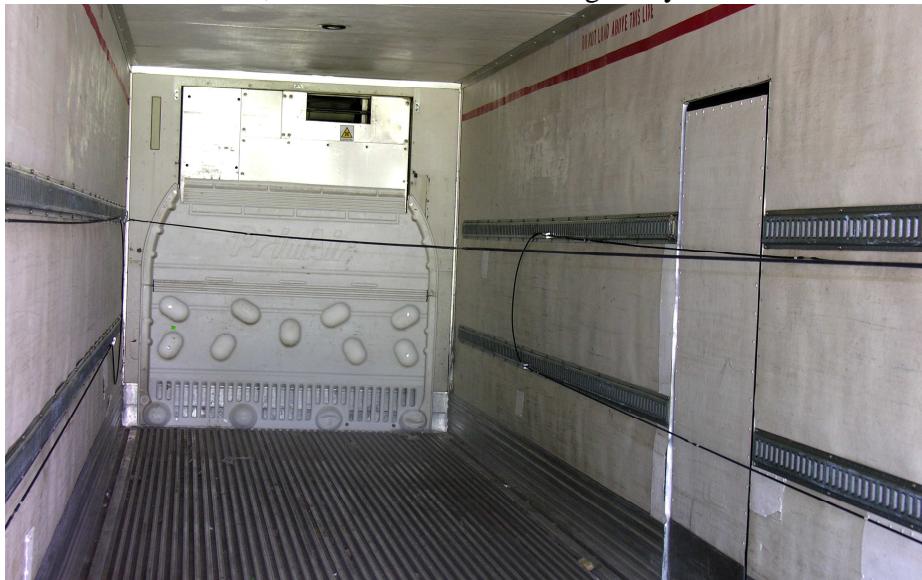
To simulate real world operating conditions of an installed temperature sensing cable, a 53 foot long refrigerated reefer was rented for two one-week periods to simulate the effects of cold temperatures of a cable under tension. This report will focus on the second rental period where cables CA008, CA009 and CA010 were tested. The reefer's refrigeration capability resulted in temperatures as low as -26°C and would regularly go through a defrost cycle bringing the temperature up to as high as 15°C. Cables were installed in the reefer as shown in the photos below. One cable was installed on each side and the shorter cable, CA009 was installed diagonally in the reefer.

Figure 13 - Reefer Cable Installation

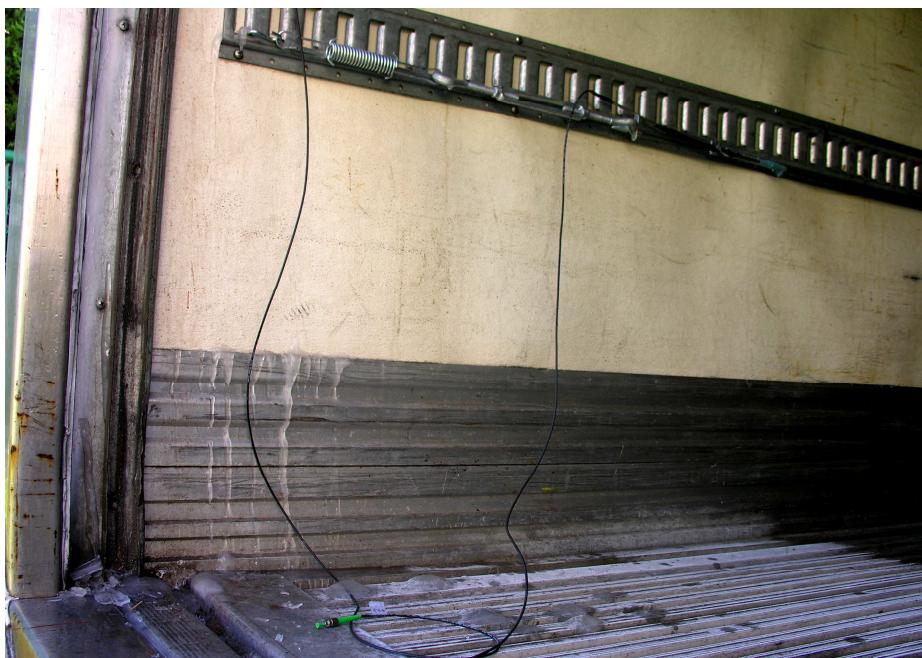
Figure 14 - Cable Tension Configuration
